# CASE STUDIES

## CASE STUDY 2: Geelong Carousel Pavilion

## CASE STUDY 3: Great Ocean Road Bridge Rails

### Port of Botany Light Towers at DP World Terminal

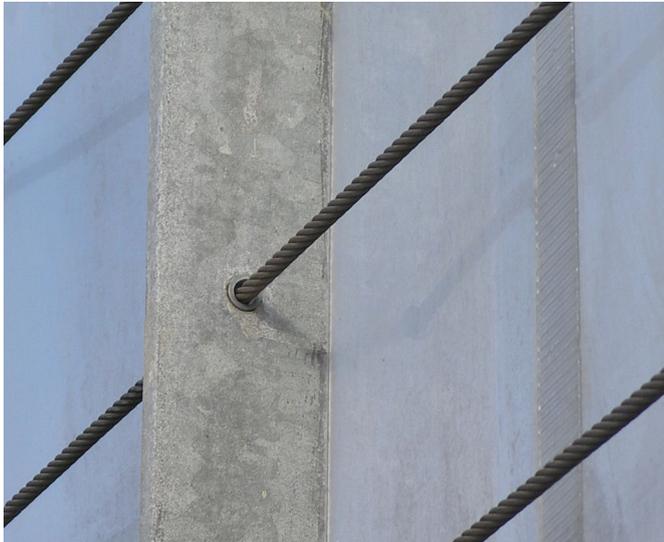
After 9 years, the average coating thickness of the structural steel is 2 to 3 times (160 – 220 µm) the required level of AS/NZS 4680.

*Use of plastic inserts prevents dissimilar corrosion between stainless steel and galvanized steel in coastal environment*

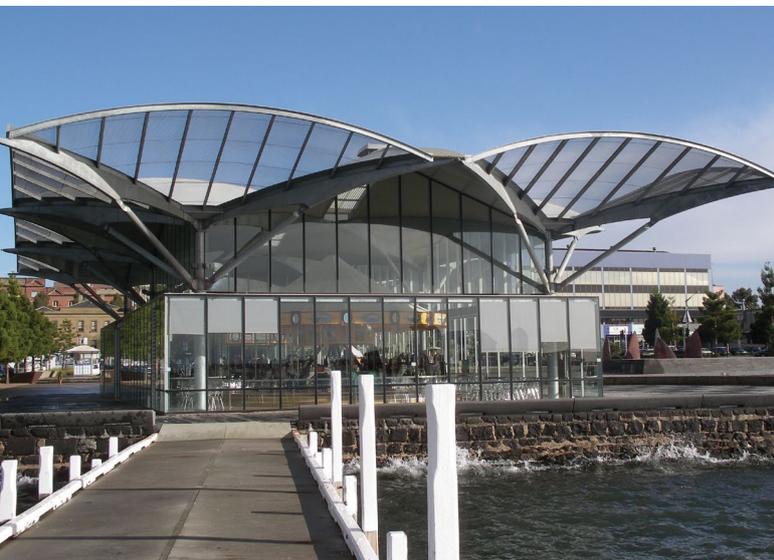
*Geelong Carousel Pavilion*

The carousel is a popular tourist attraction and during school holidays it is subject to considerable stress due to children’s parties and general public traffic. It has been open for 6 years and has required no maintenance in that time. The steelwork is in excellent condition and all of the galvanizing is 2 to 3 times in excess of the levels required by AS/NZS 4680.

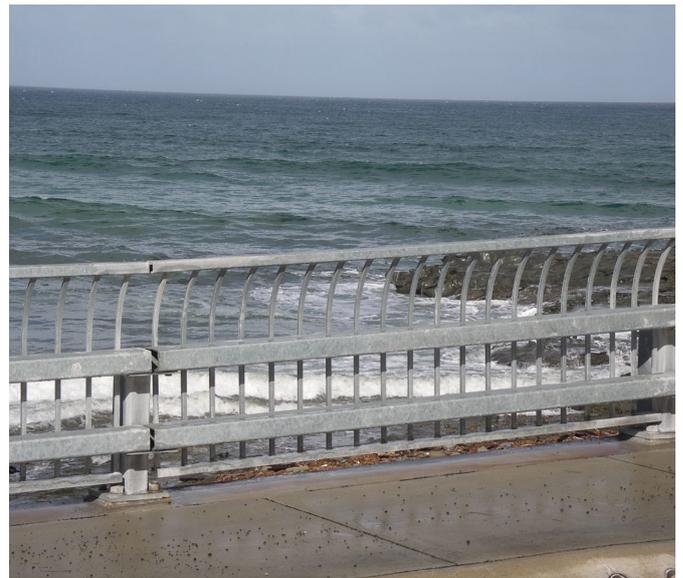
12 bridge rails were examined along the Great Ocean Road on the south-west of Victoria with the assistance of the local roads authority. All of the bridge rails were performing well and it is standard for them to be hot dip galvanized and either left bare or painted in instances where aesthetic requirements demanded. Of interest is the fact that even though many of the bridge rails were in the surf zone and approximately 10 – 30m from the breaking surf and over estuarine waters, they were in excellent condition. Conferral with the responsible engineers indicated that they were performing as expected and that a life of over 20 years with minimal maintenance was the expected performance.

*Bridge rail at Smythes Creek on Great Ocean Road (10 years old)*

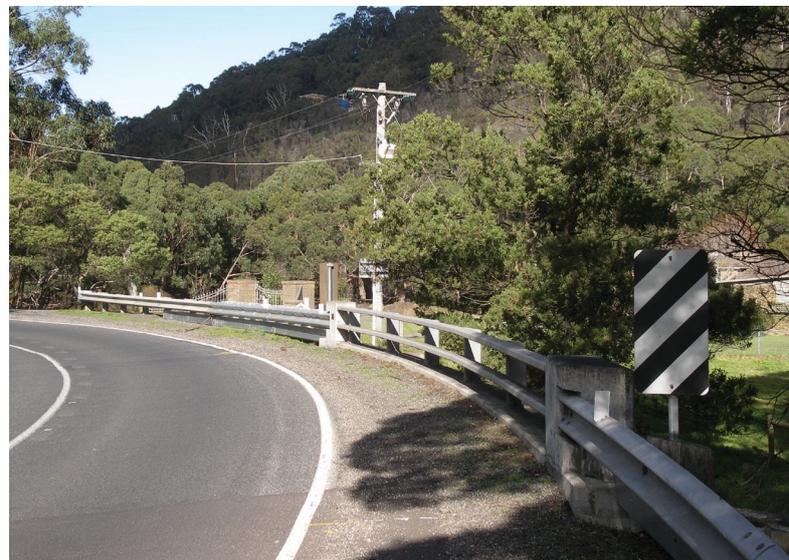
*Bridge rail at Grassy Creek on Great Ocean Road (24 years old)*

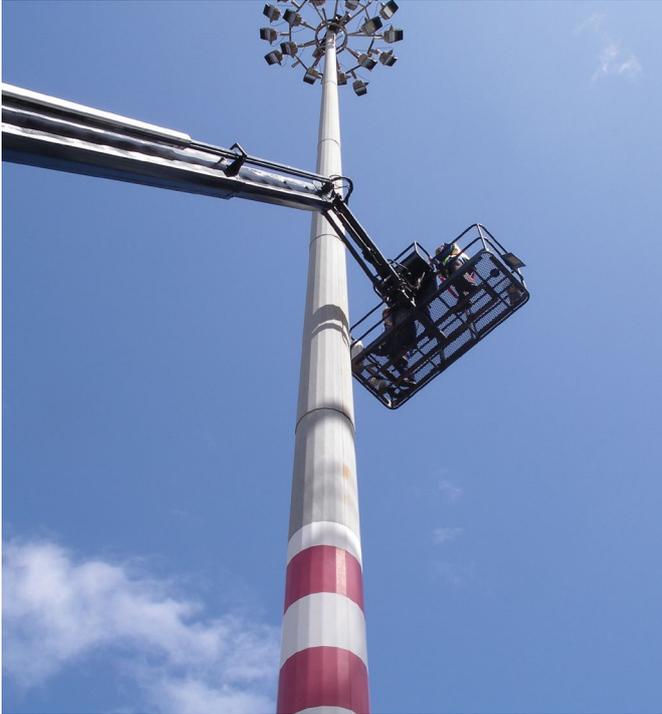
Port of Botany light tower being examined (27 years old)

The coating appeared to be in good condition considering its exposure environment and age of 27 years. All of the thickness measurements were above what would be required by Australian Standards for a new installation (AS/NZS 4680).

Based on the conventionally accepted corrosion rates for zinc and taking into account the lowest measured thicknesses for each tower, it was conservatively determined that the remaining life of the coating was approaching at least 20 to 25 years.
