HOT DIP GALVANIZED REINFORCING STEEL FOR CONCRETE STRUCTURES

70
galvanize
February 2011

Editorial
Mike Ainsley
Prepared by
Galvanizers Association of Australia

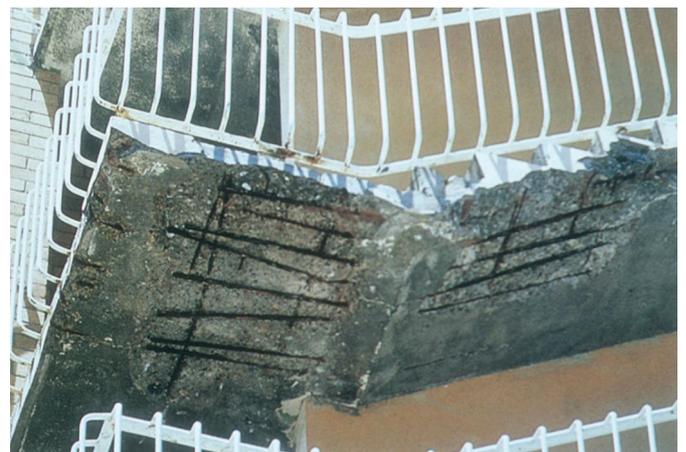
Deterioration of the bare steel reinforcement in a coastal balcony

Steel corrosion (rusting) causes the reinforcement to delaminate from the concrete, weakening the structure. Furthermore, because rust has a volume up to 10 times that of the steel consumed, significant tensile stresses are generated in the adjacent concrete. Since concrete is strong in compression but relatively weak in tension these expansionary stresses cause cracks that can eventually extend to the concrete surface. Besides further weakening the structure, the cracks cause corrosion to accelerate by providing a ready conduit for further unimpeded entry of corrodants. Eventually this self-perpetuating process leads to severe concrete spalling which then fully exposes the reinforcement to the external corrosive environment.
